Remedy Rescue at the Cleburn Street Well Site

Grand Island, Nebraska

Mary Peterson, EPA Region 7

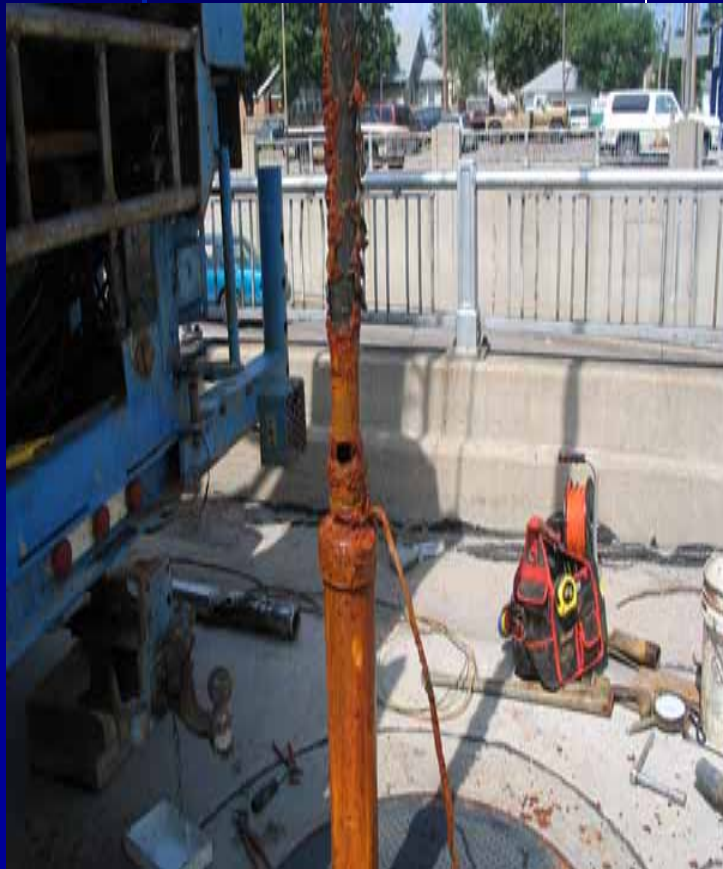
RESULTS

Pre-Opt Flow = 56 gpm

Post-Opt Flow = 110 gpm

Improve Extraction Efficiency:

- Evaluated/cleaned well screens and piping
- Replaced pumps and fouled equipment

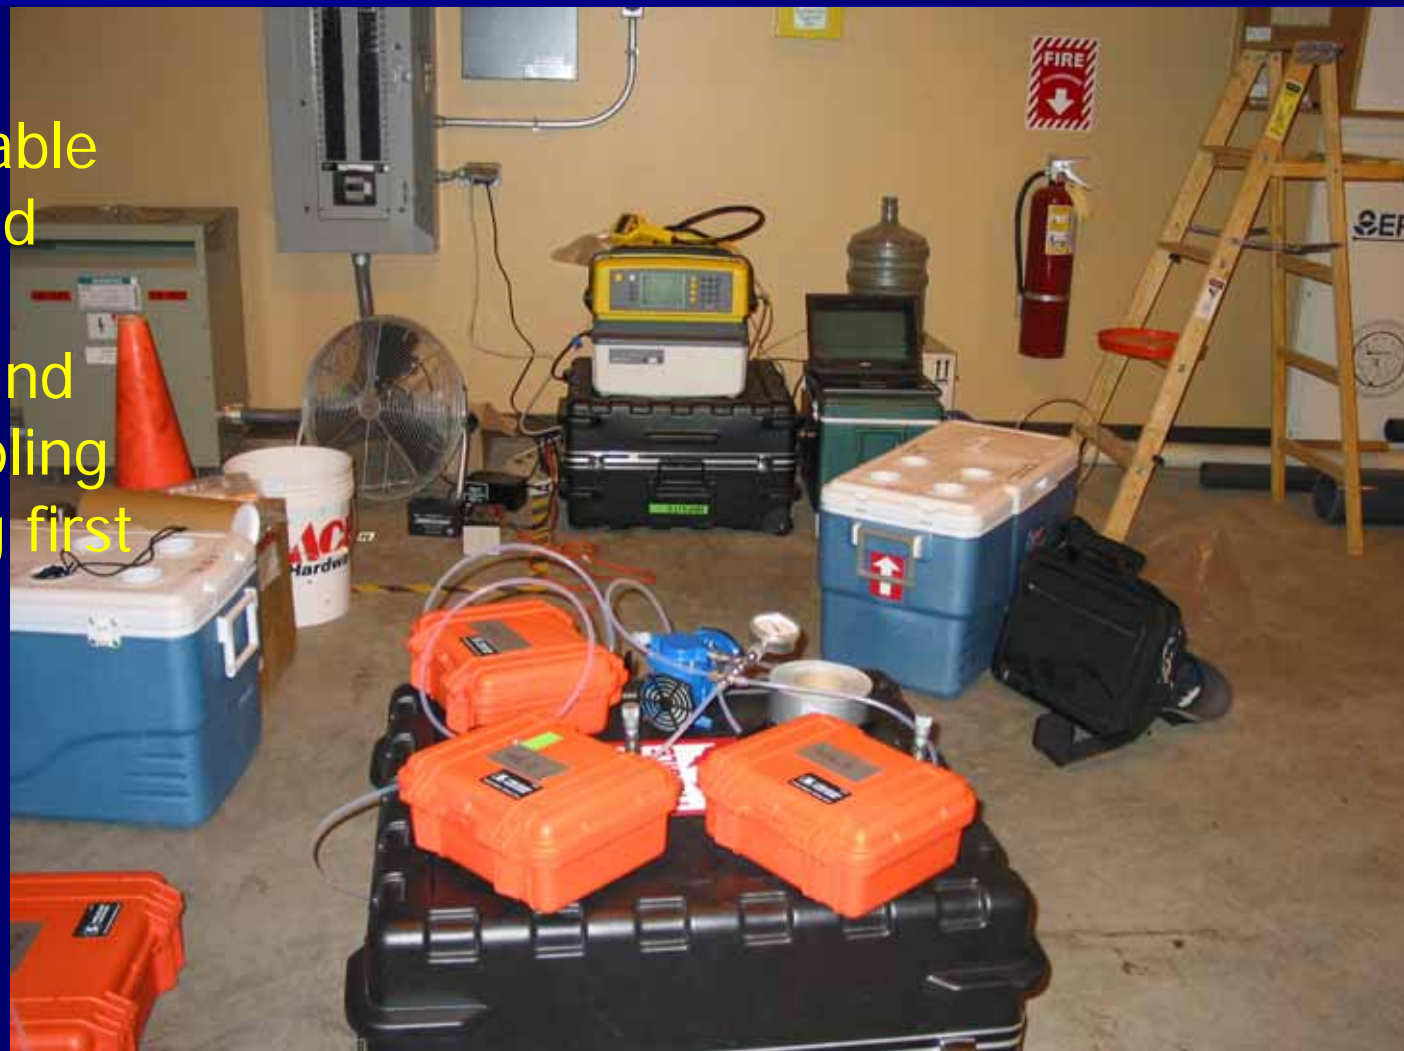
SVE Start-Up – Jan 2008

Use of a portable GC/MS allowed for quick data turn-around and multiple sampling rounds during first 48 hours.

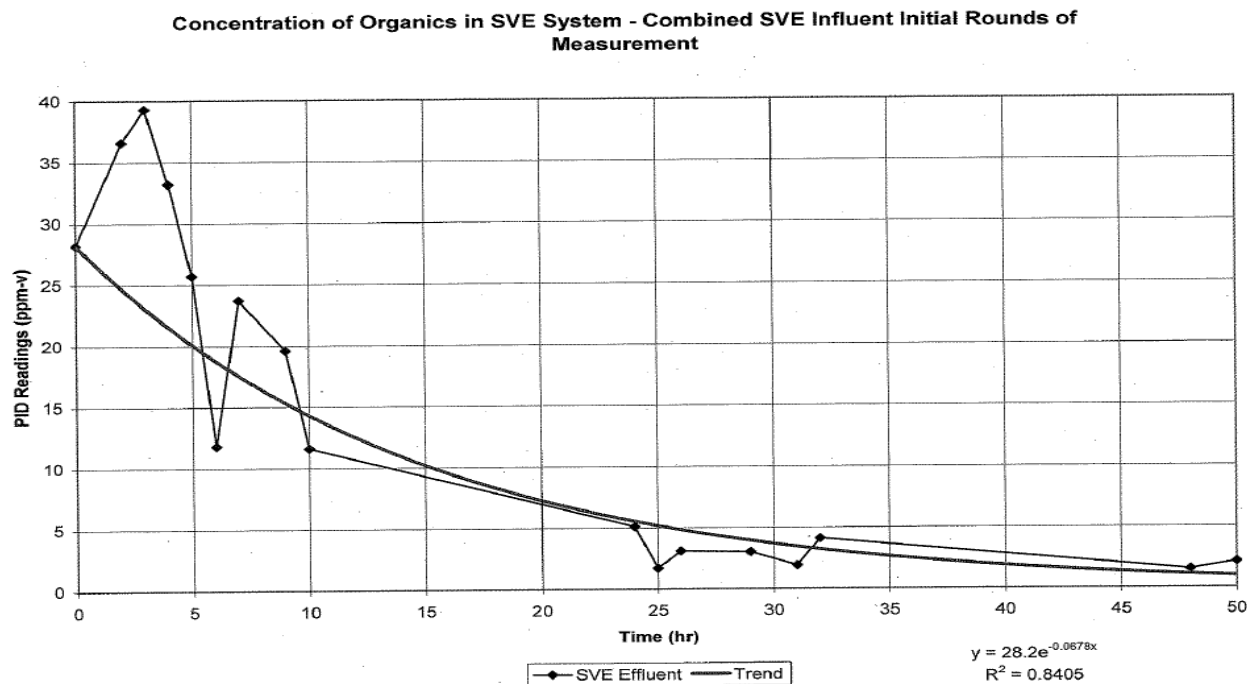
SVE Start Up – Jan 2008

PCE levels dropped significantly in first 48 hours. Sustained concentration not great enough to justify full time operation.

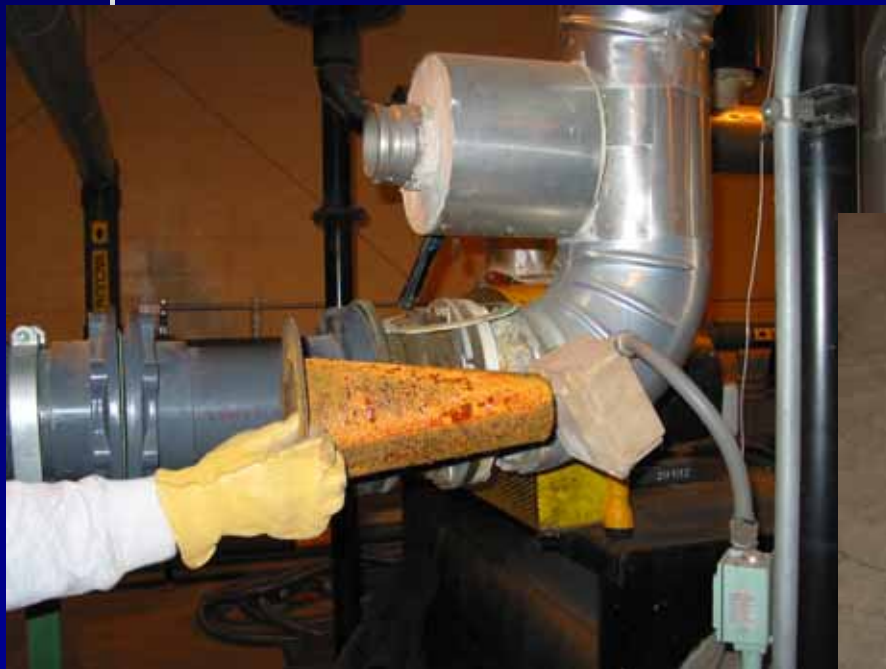
The Prairie Dog Filter?

Removal of the filter doubled our air flow; from 300 cfm to 660 cfm at same vacuum!
